USER: Power Plant

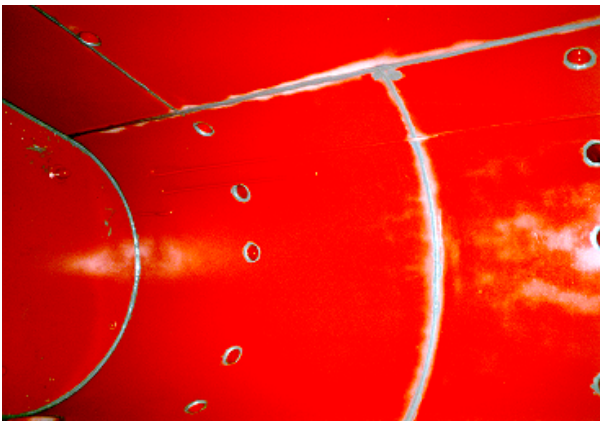
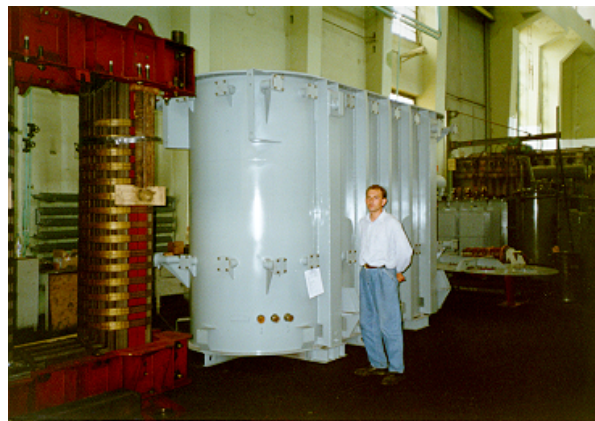
DESCRIPTION OF THE PROBLEM: A leakage of the transformer oil through untight welds connecting the sheets is an important problem in the utilization of transformers. In spite of a huge carefulness of the welders, it turns out that the problem of "sweating" of the welds is rather frequent, which requires welding corrections during tightness tests or already in the user's premises.

DESCRIPTION OF THE REPAIR: There was suggested a preventive coverage of the whole length of the welds inside the container (transformer TON 40000/110) with **Chester Metal Ceramic F**. The welds put on sanded or polished sheets after defatting with **Chester Cleaner** were covered with the aforementioned material with the help of a short, rigid brush.

ACHIEVED EFFECTS: A test of the tightness of a small container wrongly welded on purpose and protected with the aforementioned technology was carried out in this plant in the Transformers Assembly Department. The pressure test of 0.8 MPa with a penetrator and a lamp showed 100% of tightness of the protected welds. The preventive protection of the welds will allow us avoid costs connected with guarantee (or postguarantee) repairs resulting from the necessity to remove the leakage or dribbling of the oil outside the machine.
